## *Creating Durable Concrete Floors*

**We help owners, engineers and facility managers solve tipping floor durability problems.**

# Improving Concrete Tipping Floors

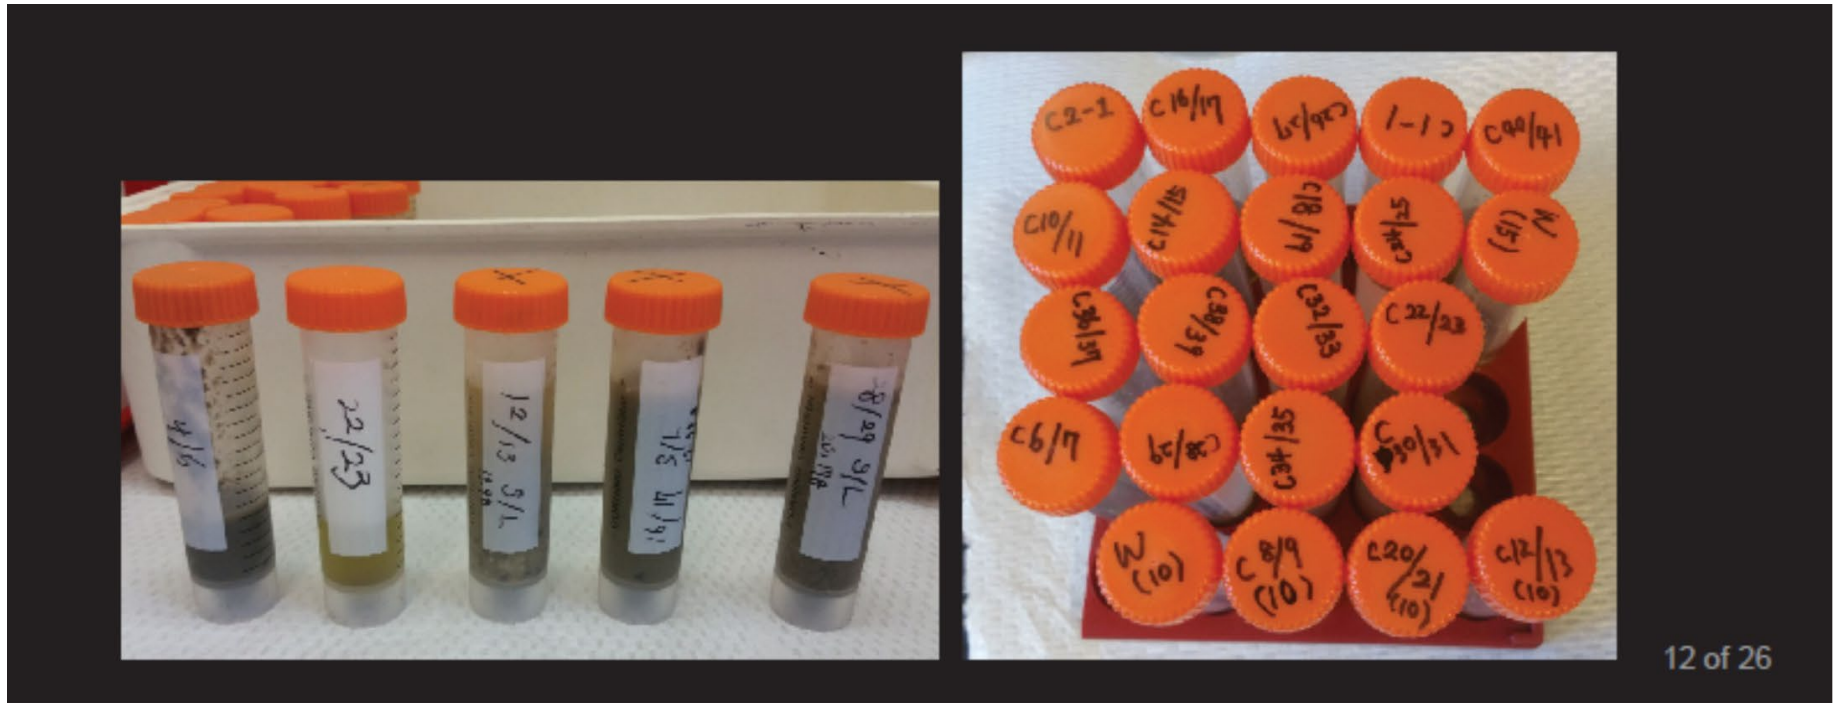
A number sample were collected from landfills, transfer stations and anaerobic digesters.

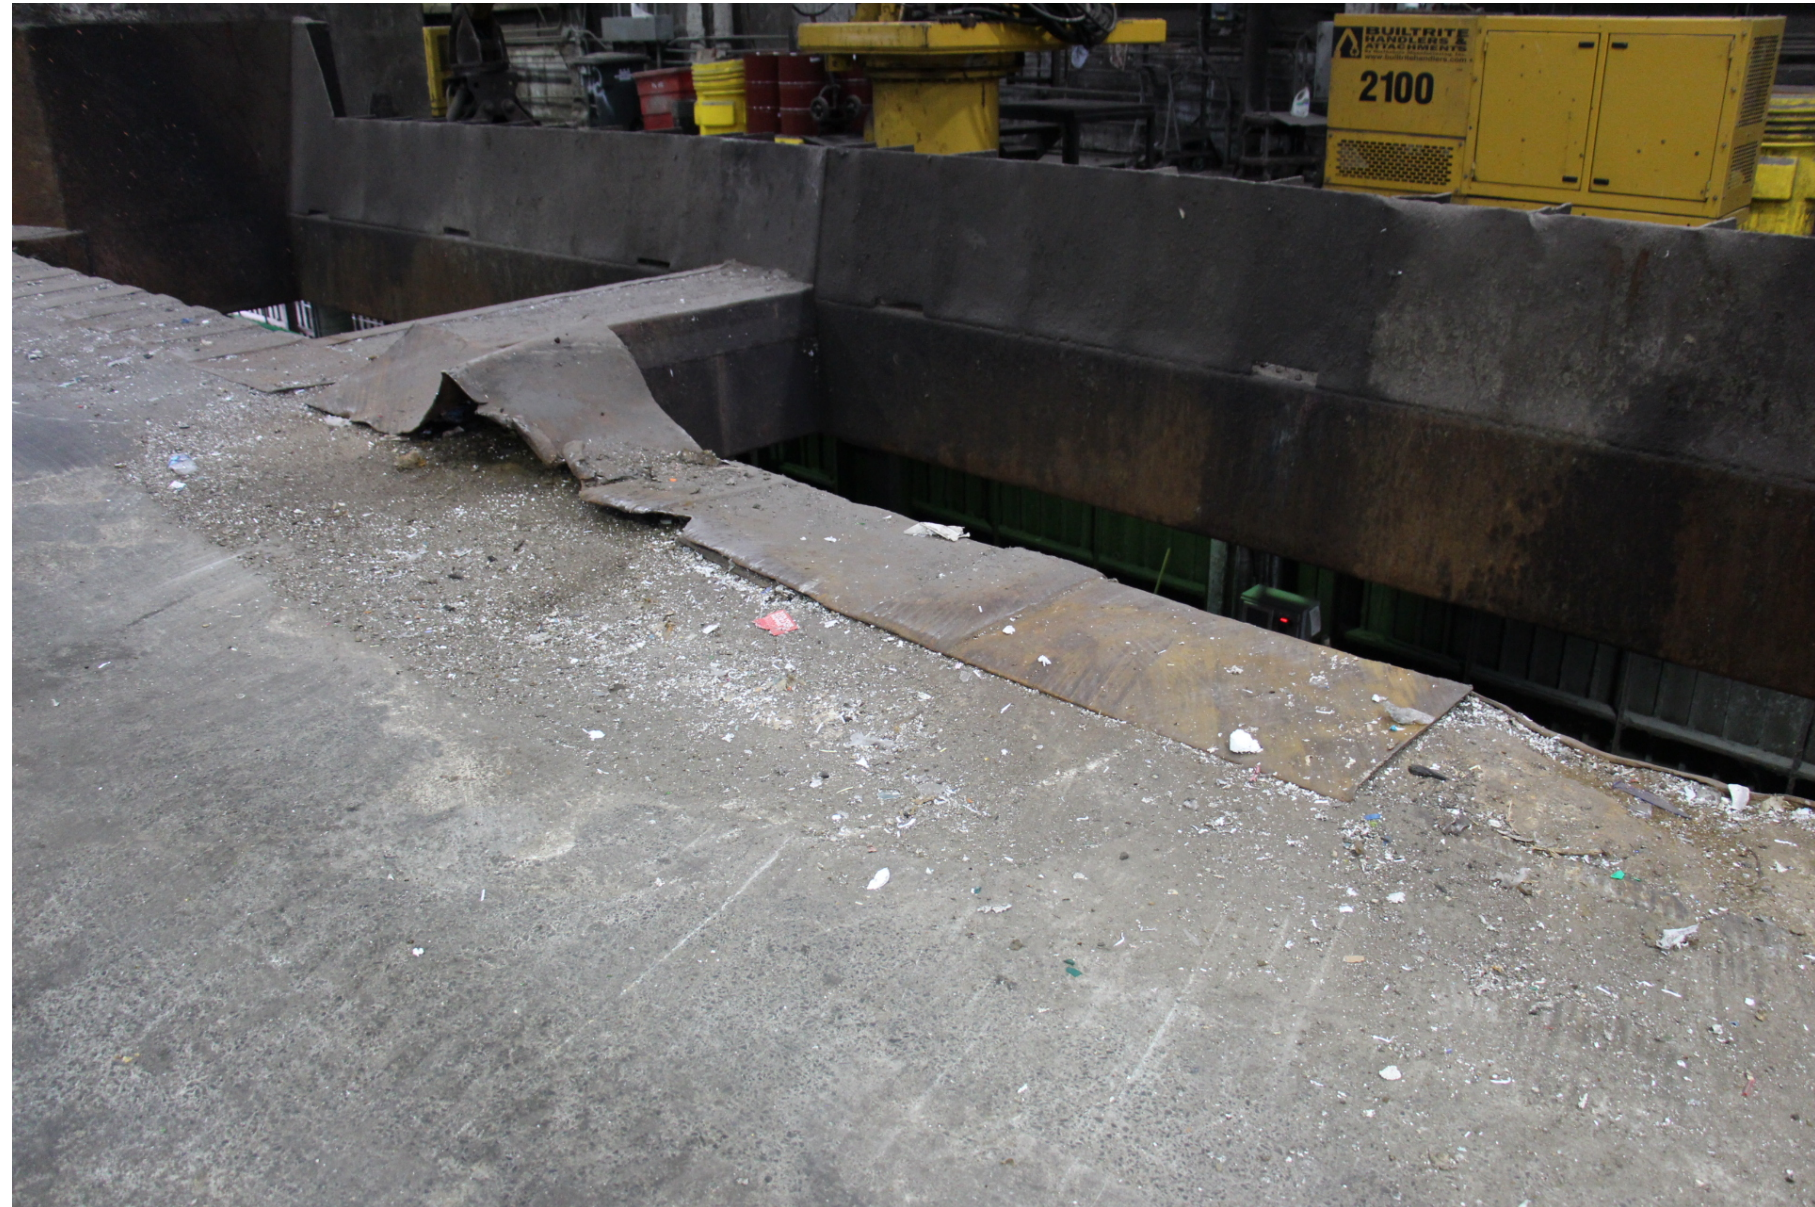
Steel around  
port edge

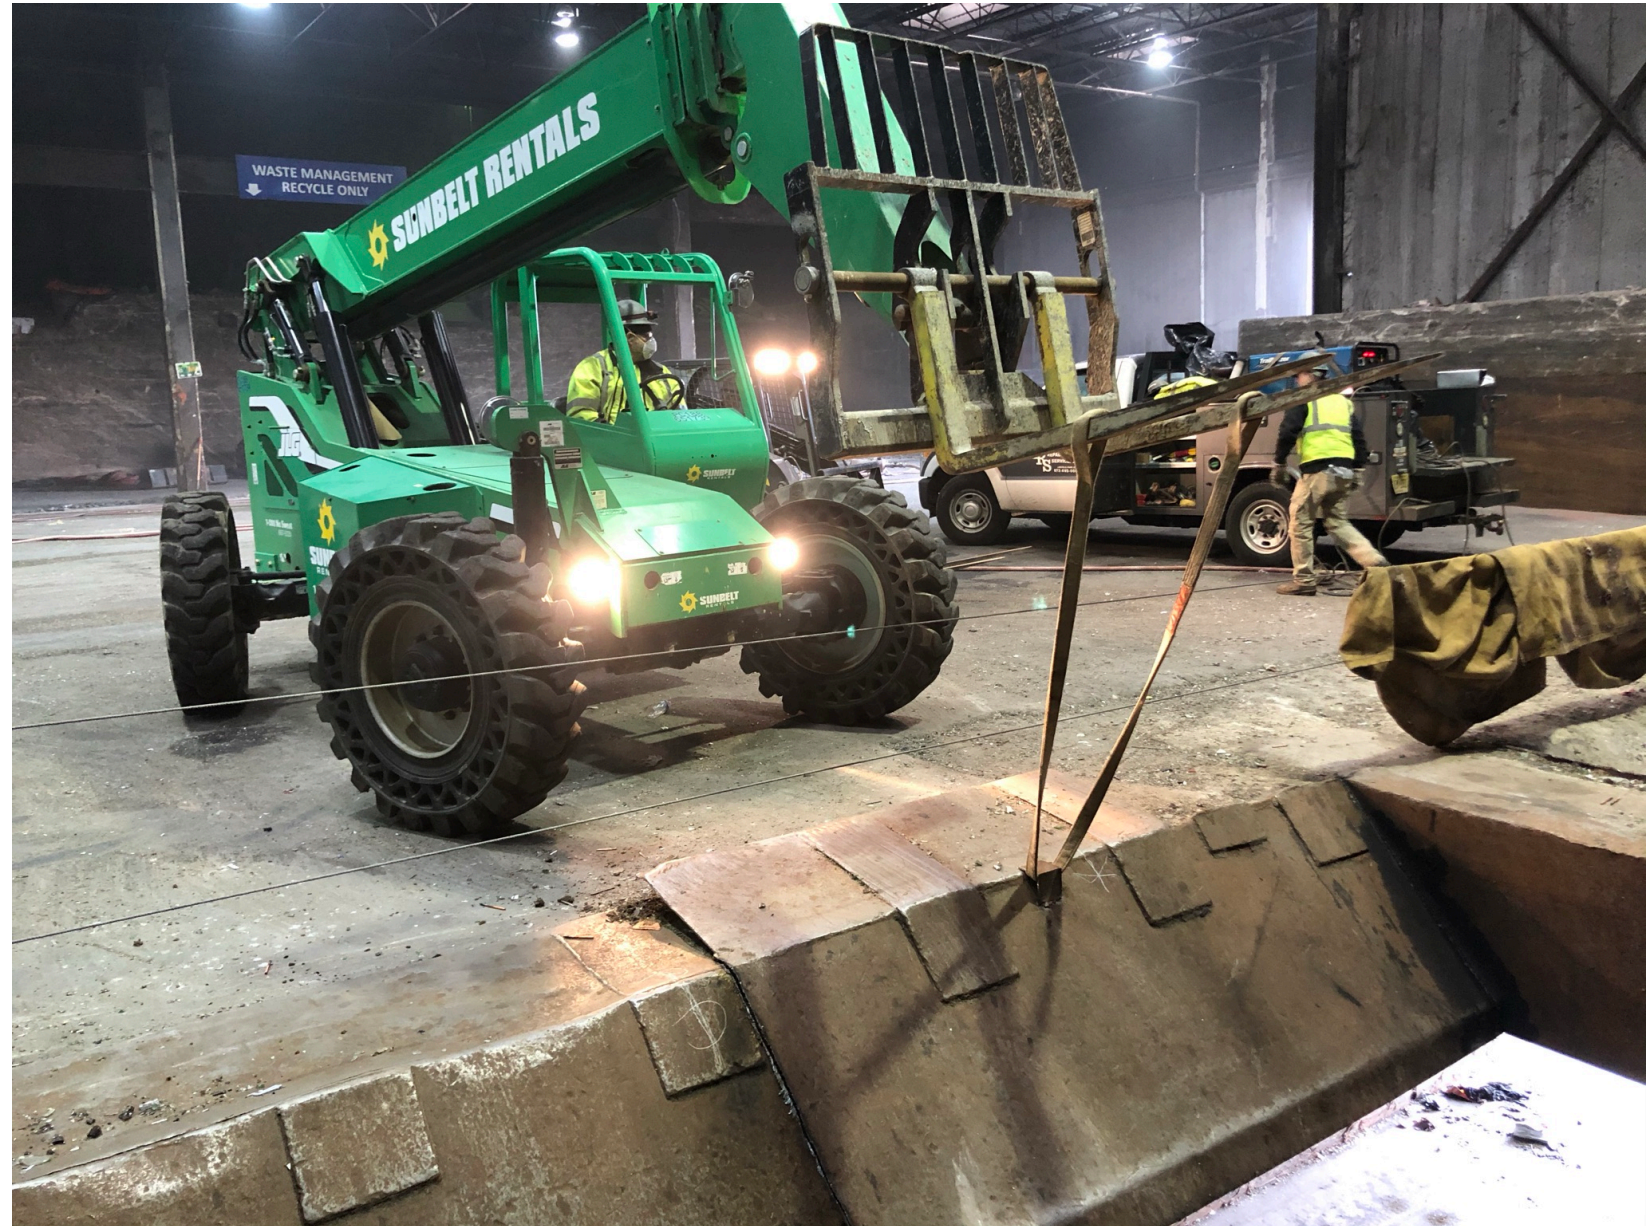
Steel around  
port edge

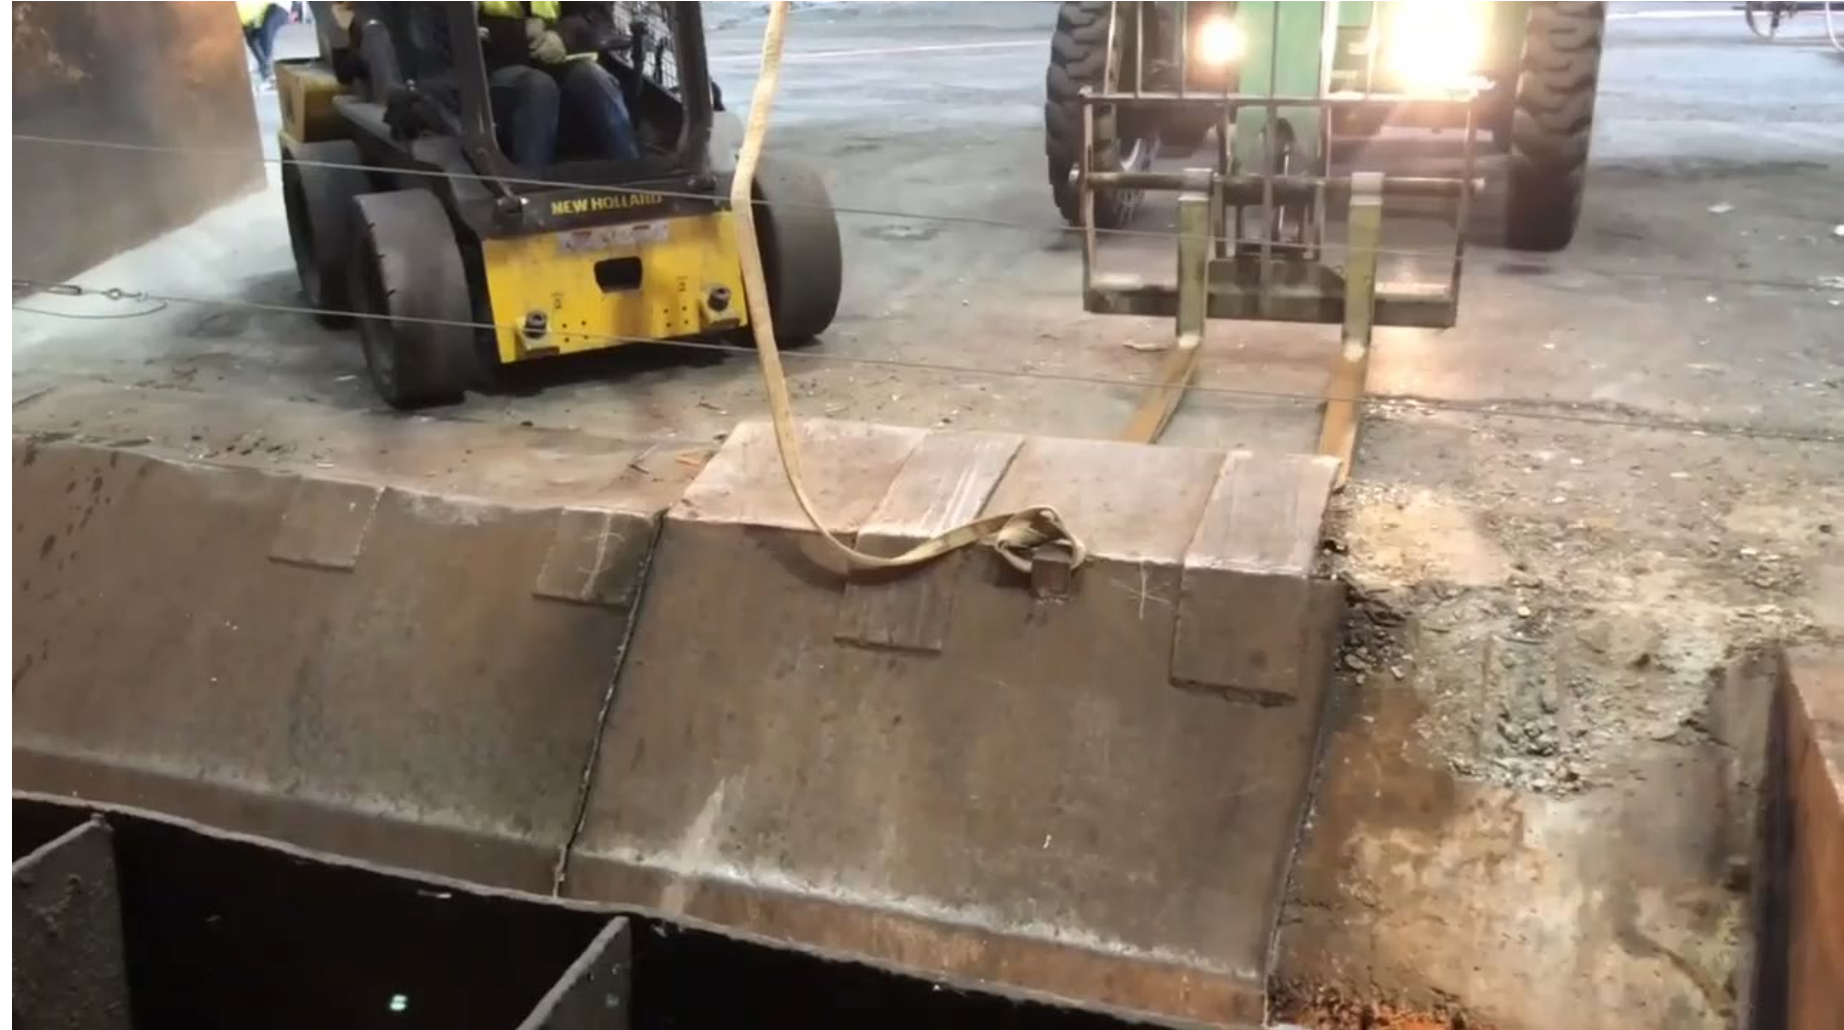
Steel around  
port edge

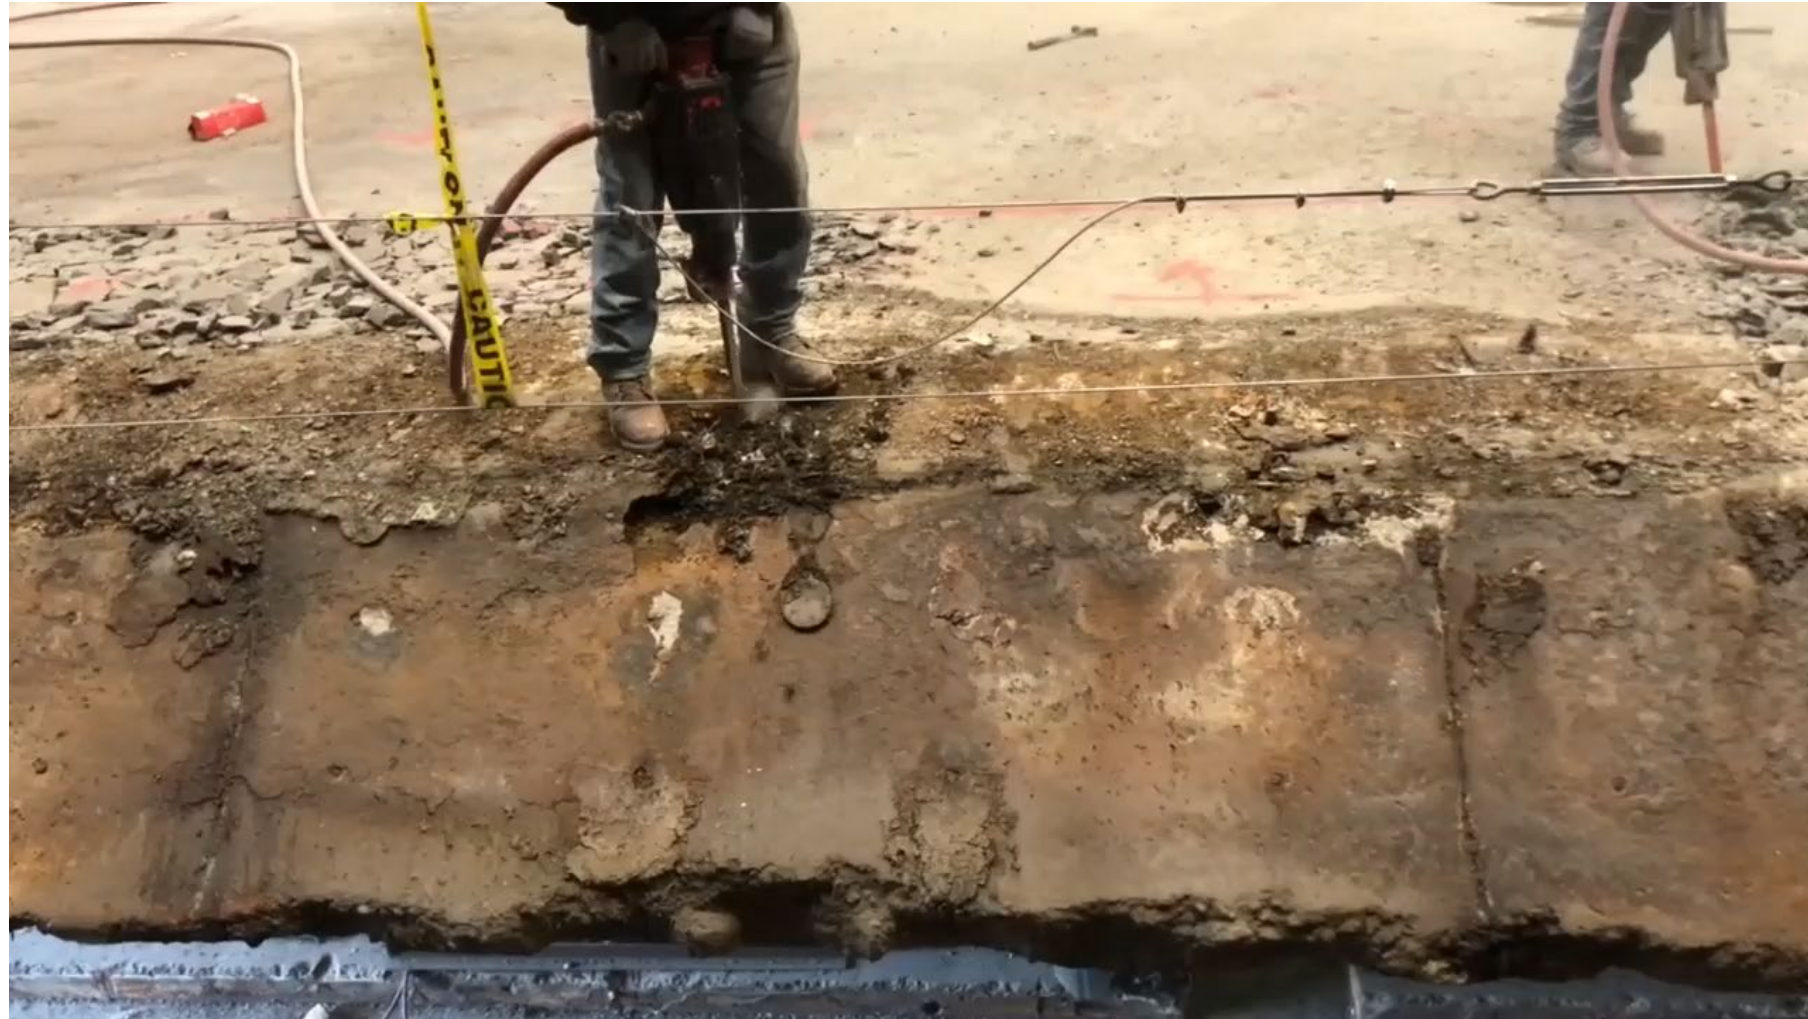
Steel around  
port edge

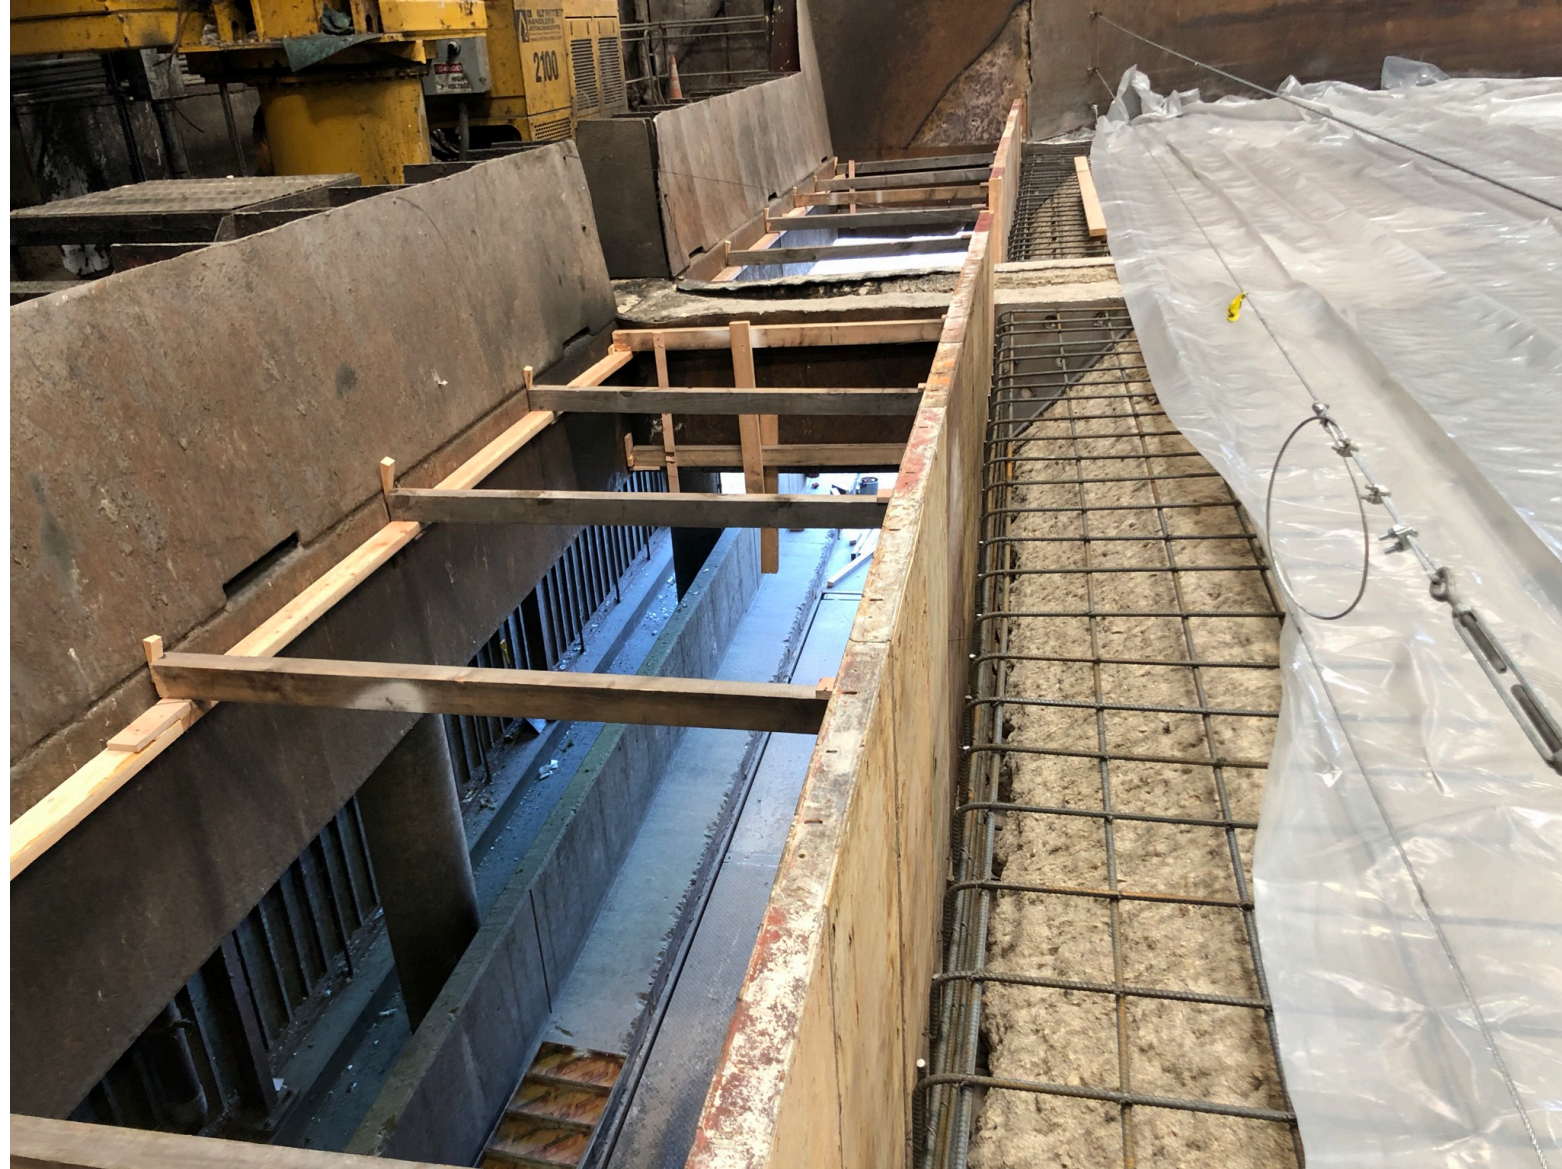
## Port Edge Repairs

Do away with steel entirely.

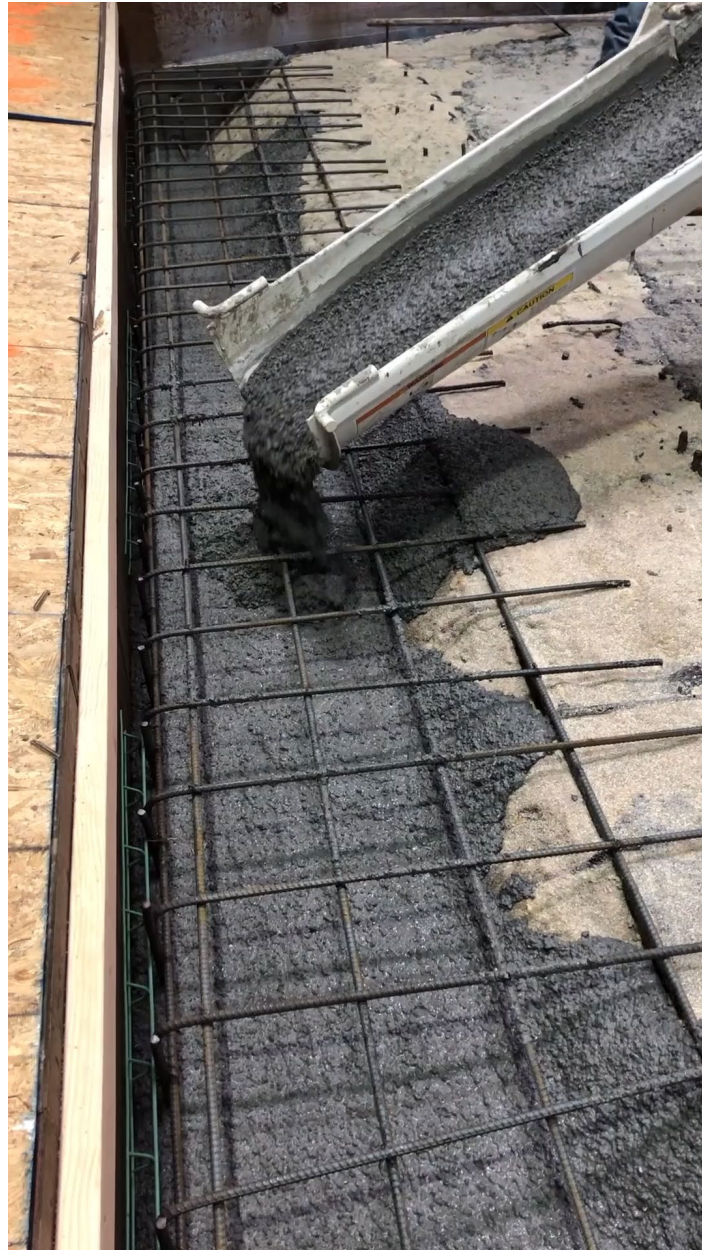
## Port Edge Repairs

Do away with steel entirely.

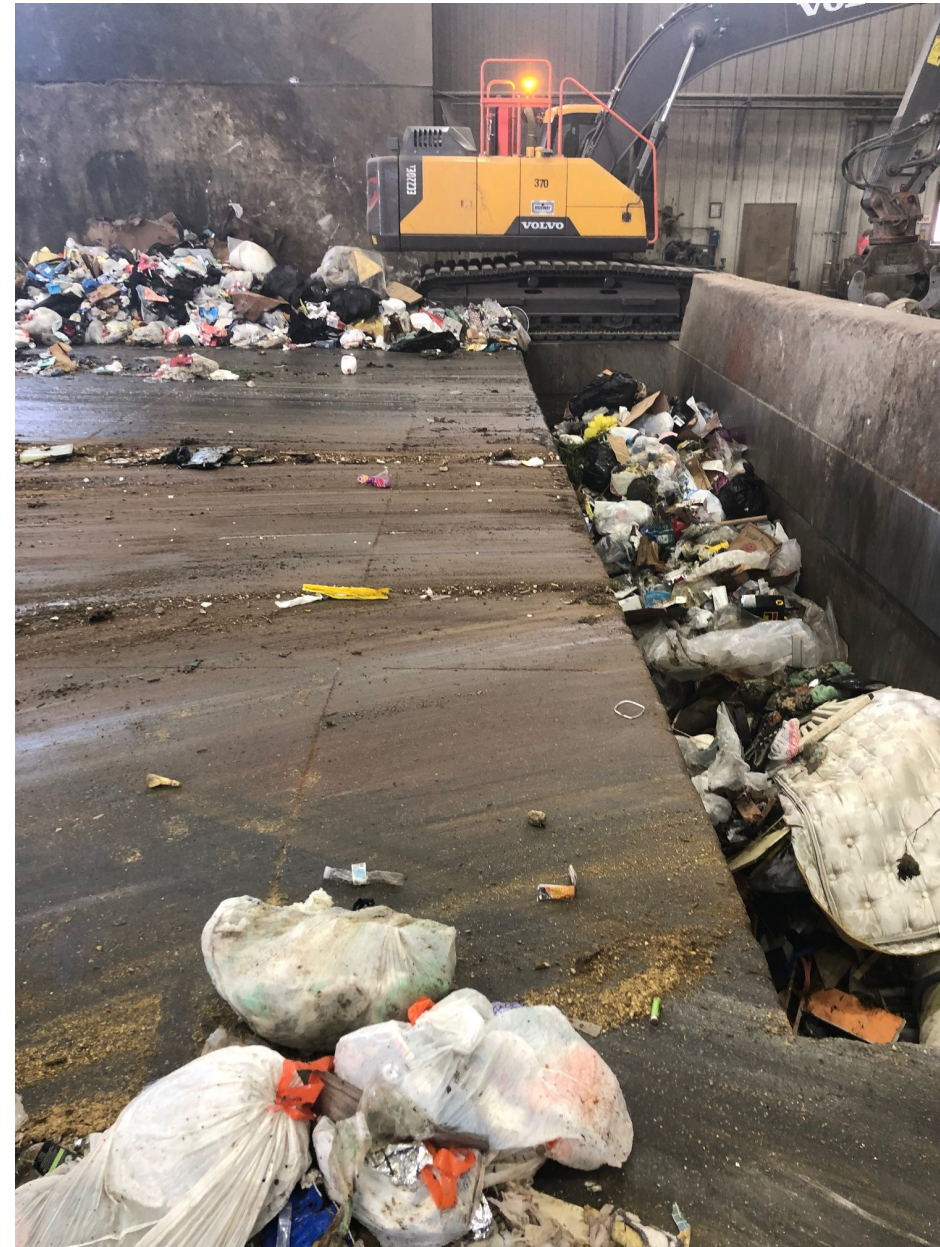
## Port Edge Repairs

Do away with steel entirely.

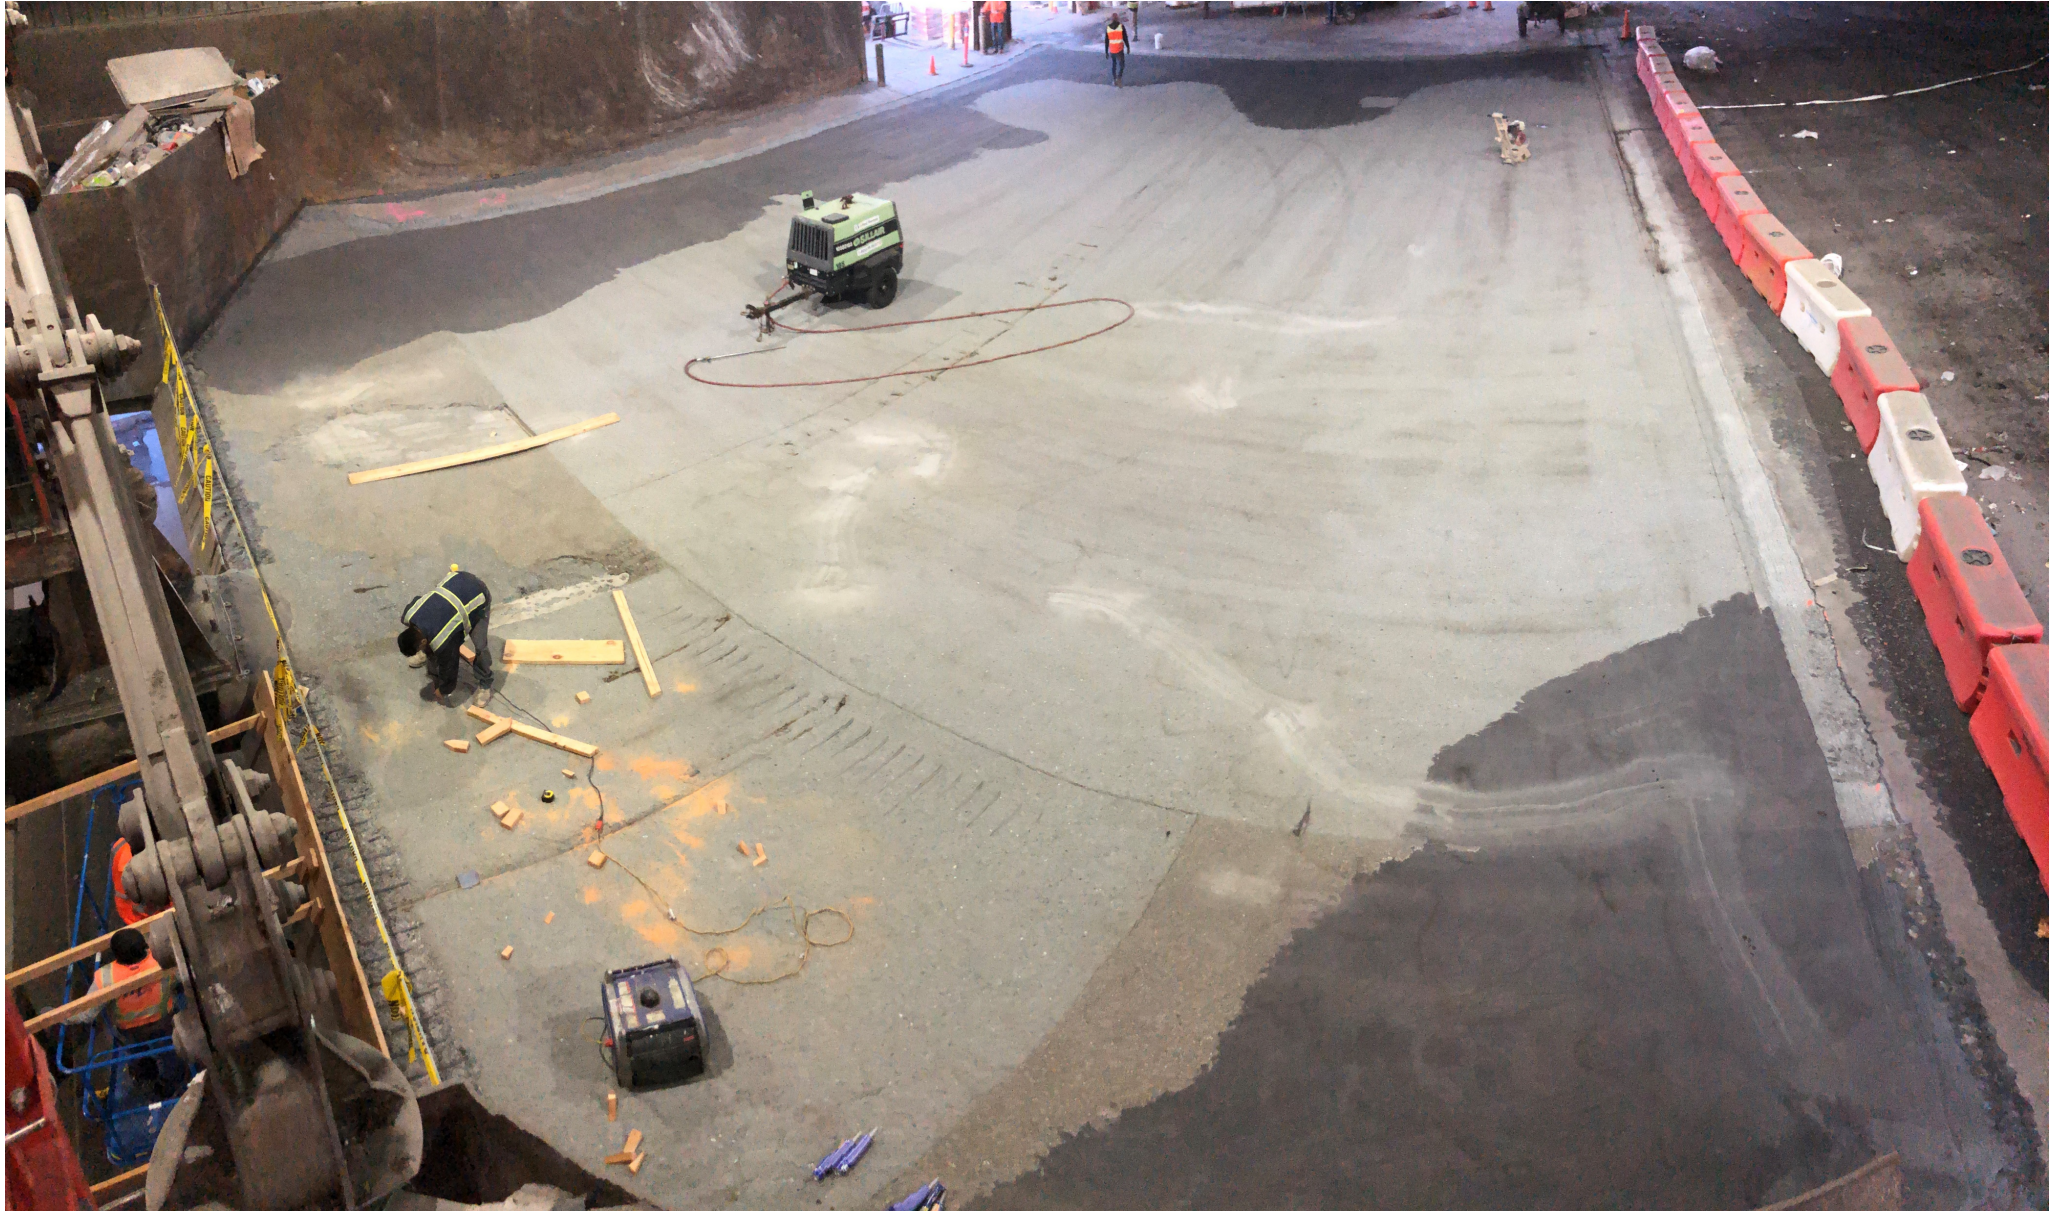
**The Floor  
doesn't  
wear  
evenly**

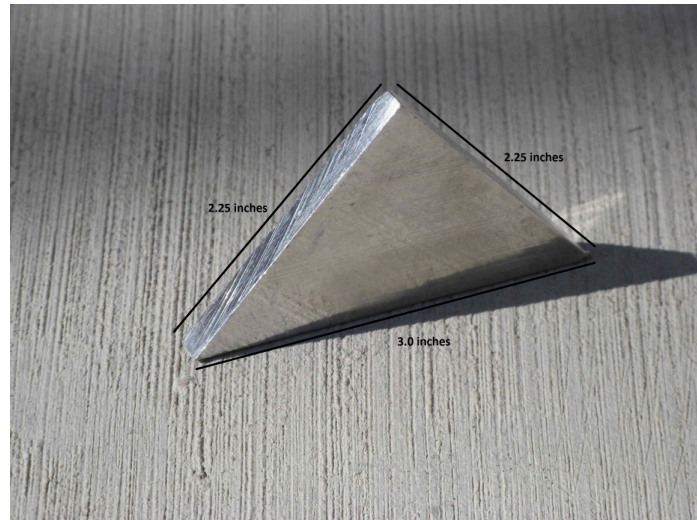
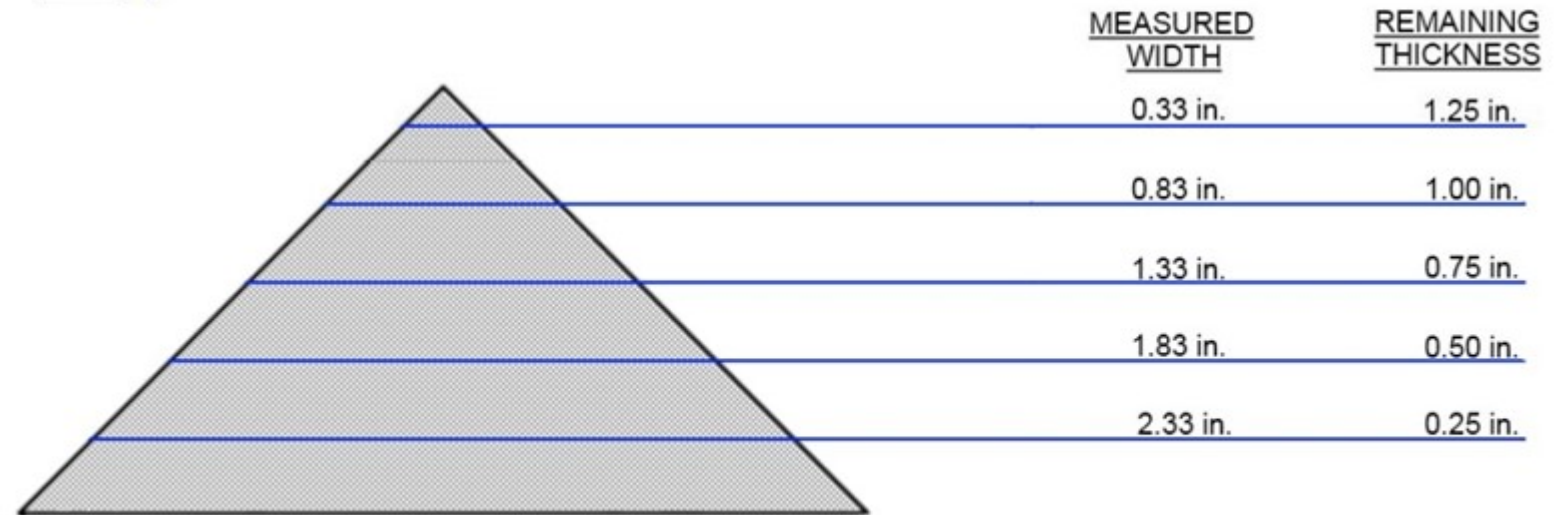
## TIPPING FLOOR WEAR INDICATORS

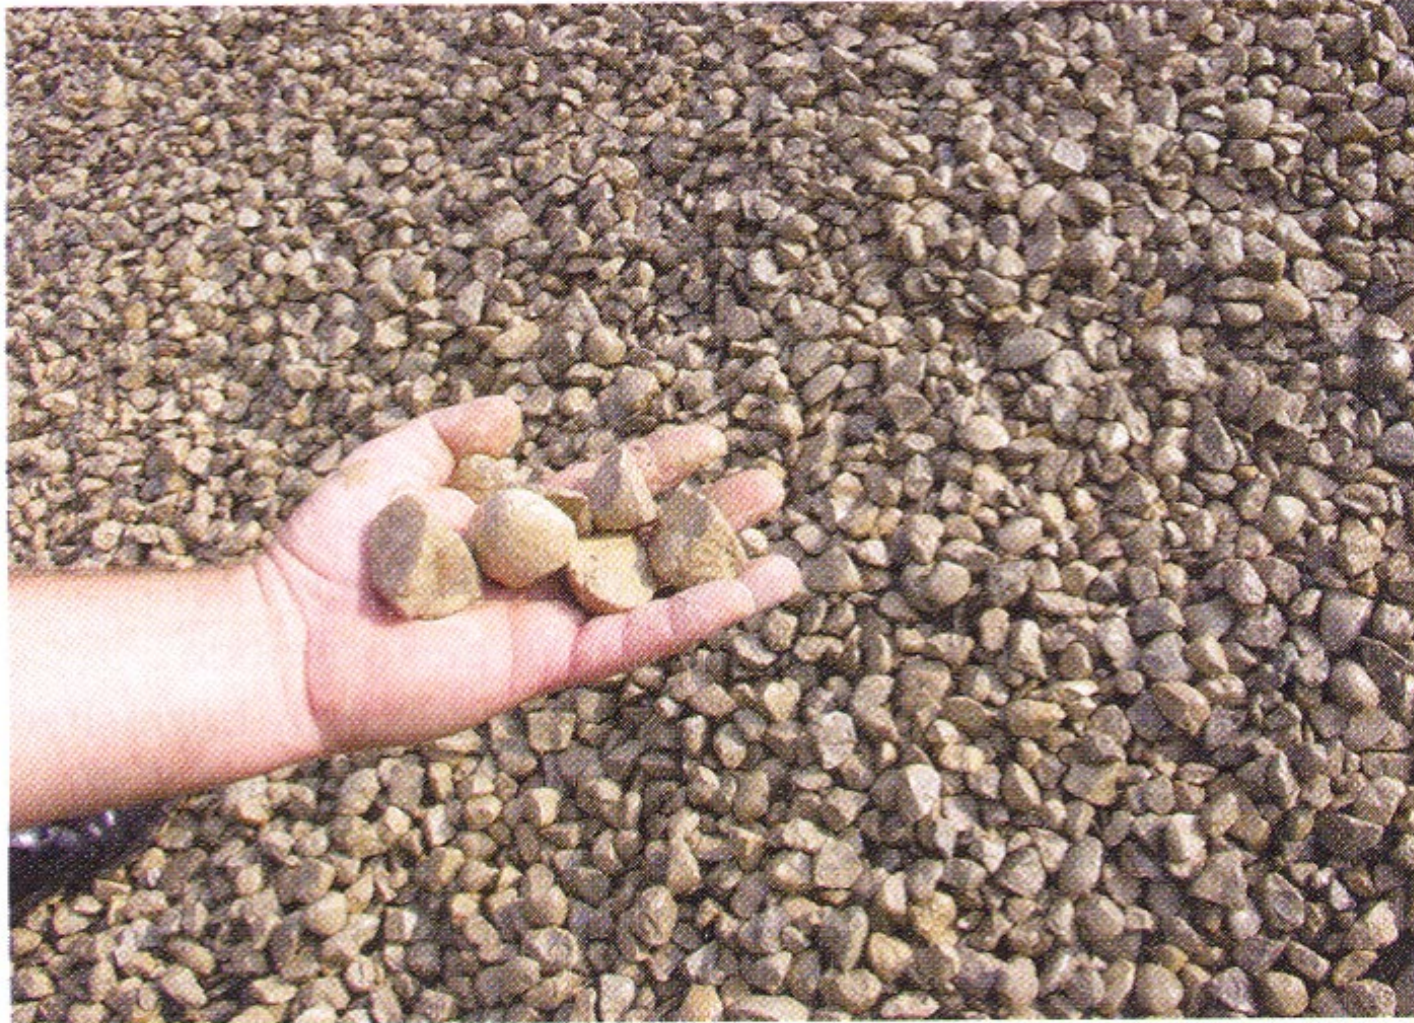
**Fig. 3: Coarse aggregate used for the distribution center concrete (No. 467 stone [37.5 to 4.75 mm])**

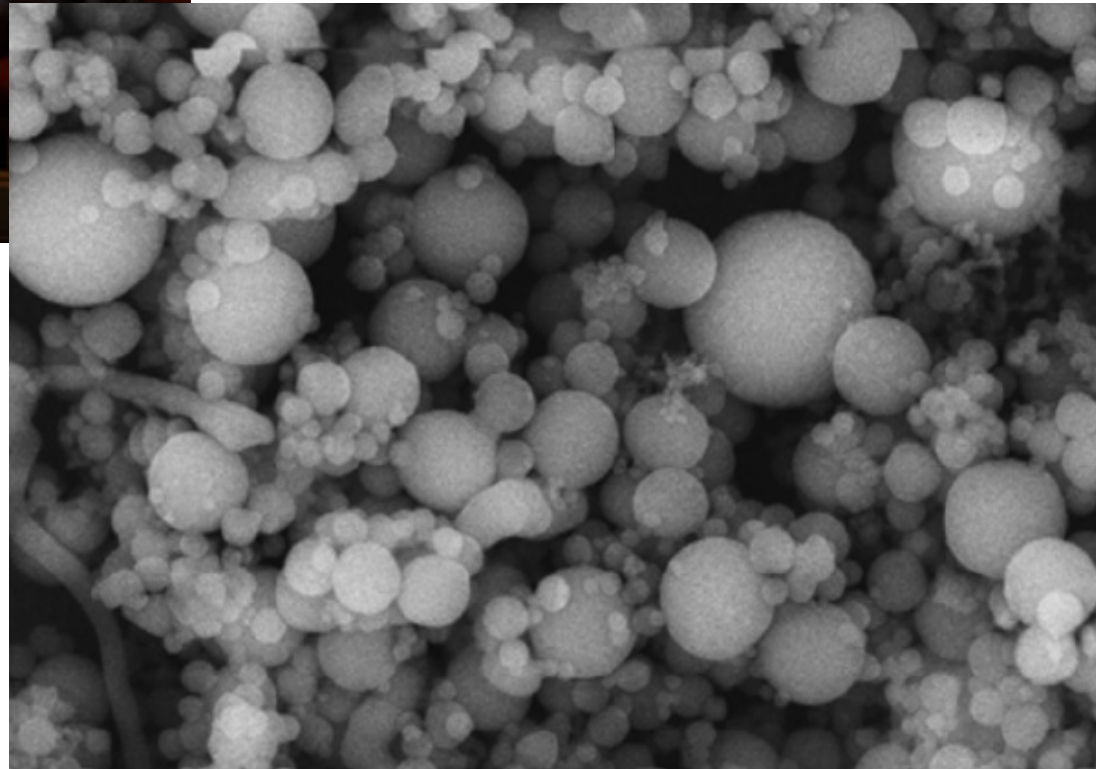
Silica Fume / Micro Silica  
By product of Electric Arc  
Furnaces used in making steel

**Also rounded and  
1,000 times smaller  
than cement particles.**
